# **Engineering Report For:**

## **Davis Creek Phosphorus Reduction Study**

**Prepared for:**  
**Kalamazoo County Drain Commissioner**  
**Kalamazoo, Michigan**

**September 16, 2011**  
**Project No. G090661TS**

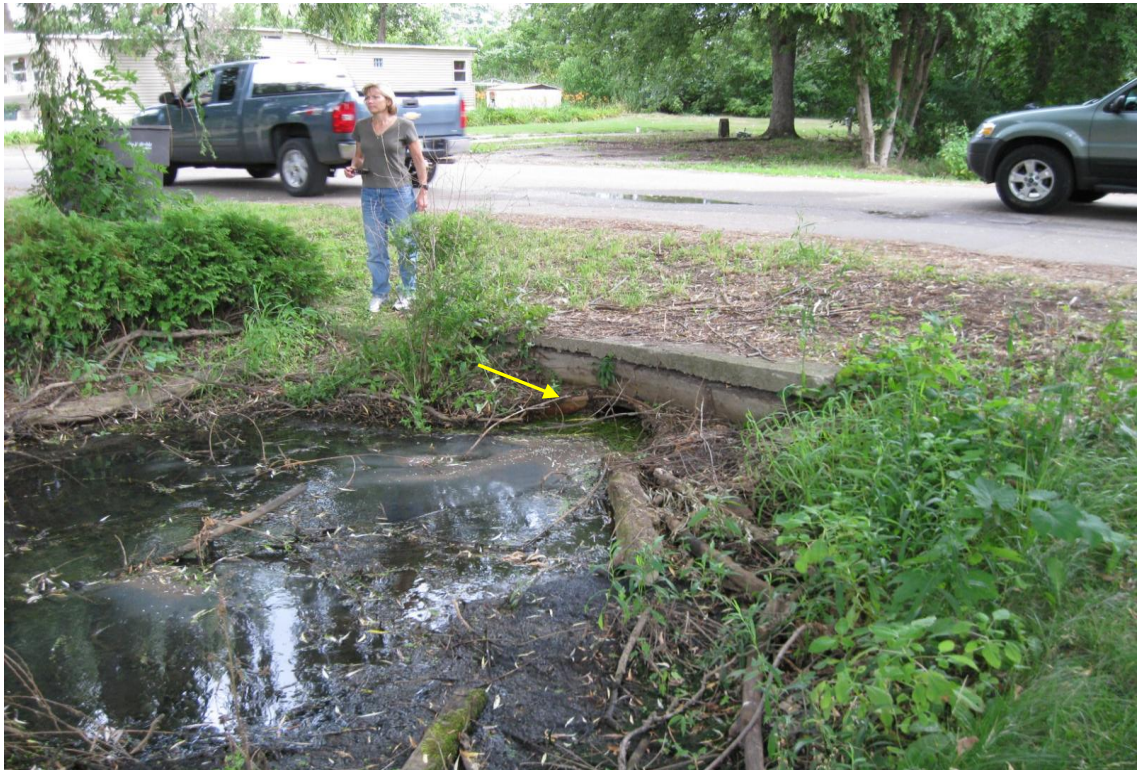
**Area 1 – Colonial Acres (West of Deadwood)** – Colonial Acres is located south of East Kilgore Road (East N Avenue) between Meredith Road and the Kalamazoo Municipal Airport. The channel within this area extends for a distance of approximately 1,700 feet, from Kirby's Circle to E. Deadwood Drive. Within this area, the Davis is over widened with virtually no flow and stagnant water conditions and is considered a safety concern from flooding and water quality. At the time of inspection, the Davis was near top of bank and even a small precipitation event would have likely flooded homes and roads within Colonial Acres. The culvert located under Hamilton Drive, immediately upstream of E. Deadwood Drive, was filled with sediment to within a few inches of the top of the culvert, limiting its ability to pass little, if any, storm water. It is important to note that the lack of flow within this area is not the result of blockages but rather due to an over-widened channel within a topographically low area and a perched culvert at E. Deadwood Drive. Hence, the Davis is functioning more as a wetland complex, storing water rather than conveying it. Water freely flows through the culvert under E. Deadwood Drive; however the invert elevation of this culvert is approximately 2 feet above the culvert under Hamilton Drive.

Plugged culvert; stagnant water

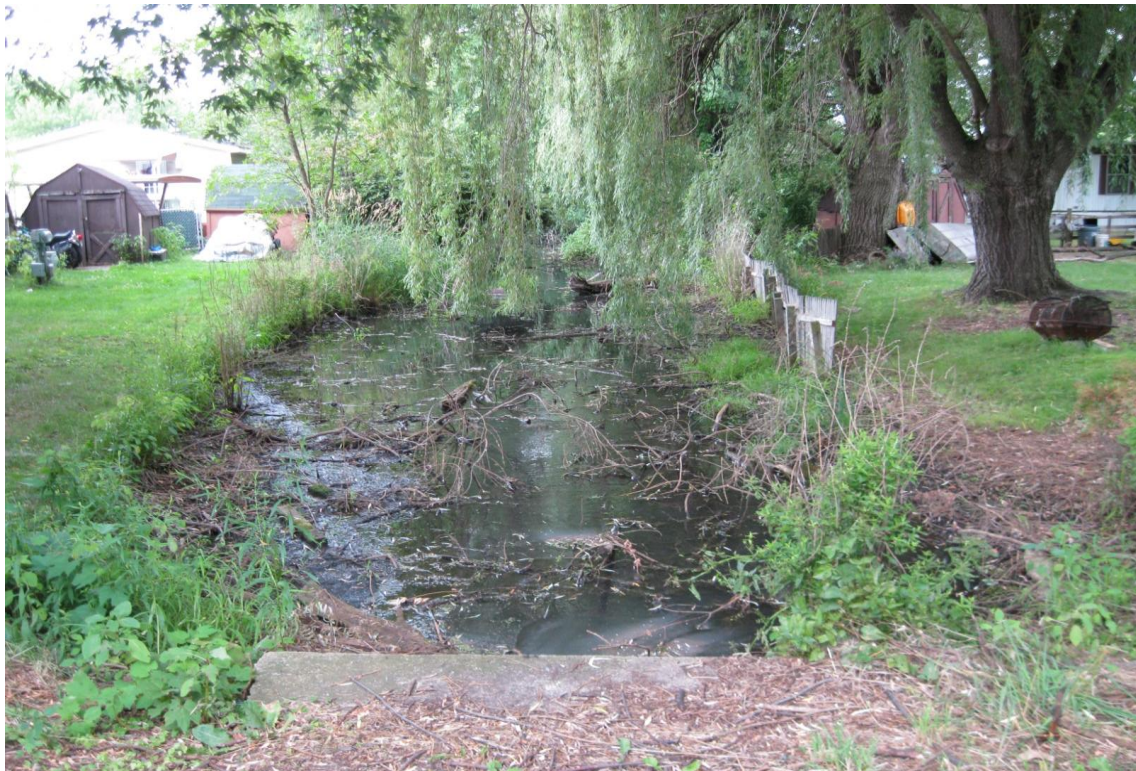
Stagnant water conditions; no flow due to mucky and organic silts and soils

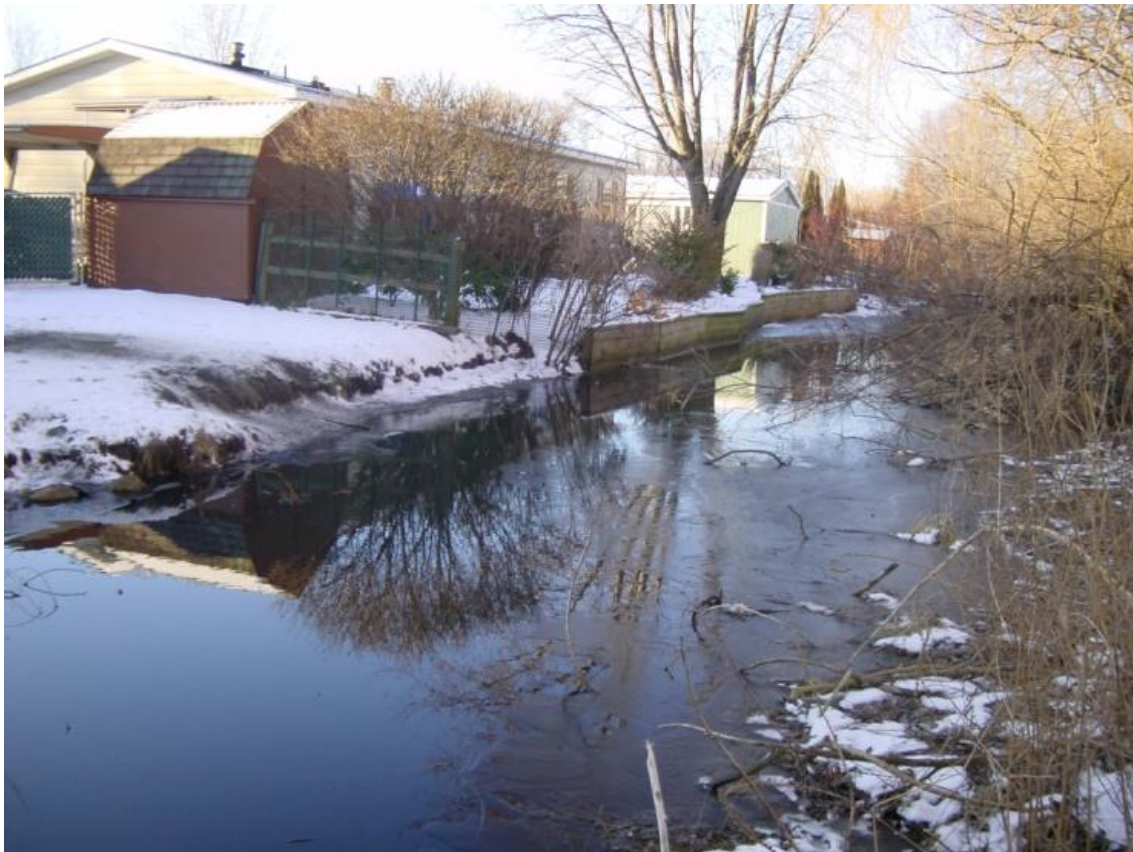
Stagnant water; bank erosion; over-widened channel

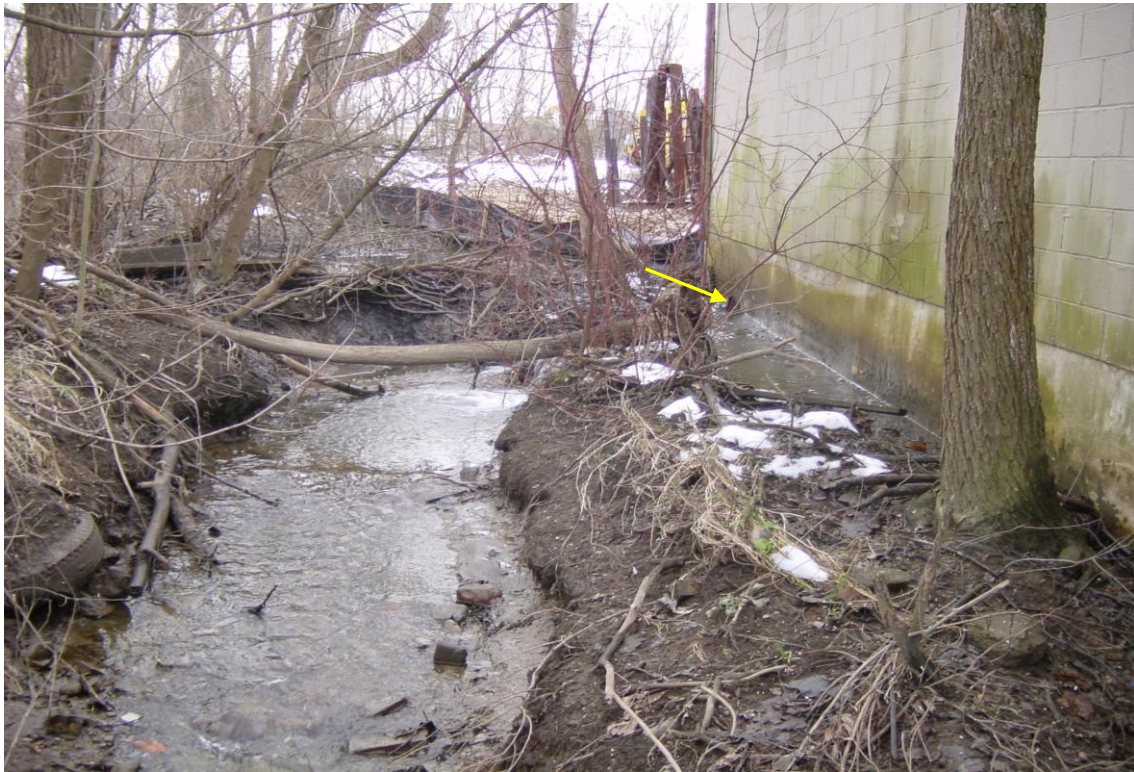
**Area 2 – East Cork Street** – For a distance of approximately 700 feet, from just downstream of the NYC Railroad Bridge to East Cork Street, the drain is completely unstable with an erratic pattern, eroding channel banks and multiple bars. The channel within this area has multiple channels, failed culverts and has migrated west where it is undercutting the foundation of an abandoned brick building. A portion of the channel also flows perpendicular to the culverts it used to flow through, and now flows over them creating a small waterfall. In addition to the channel's instability, it is also hydraulically inefficient and poses a safety concern due to various types of debris which have been disposed of in the Davis. Channel instability within this area is, and will continue to adversely impact water quality and channel stability to downstream waters. Lateral bank erosion is occurring at a rate of 0.5 foot per year.

Meandering, unstable channel undercutting building

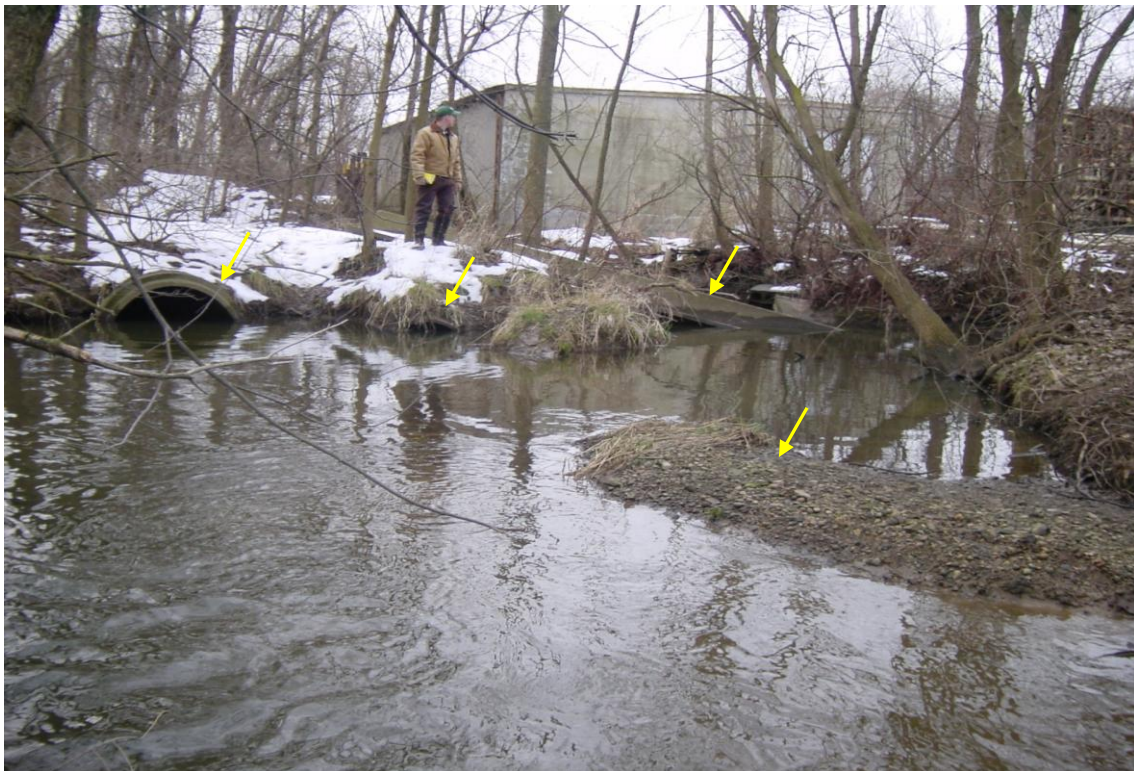
Sediment bars, blockages and failed culverts

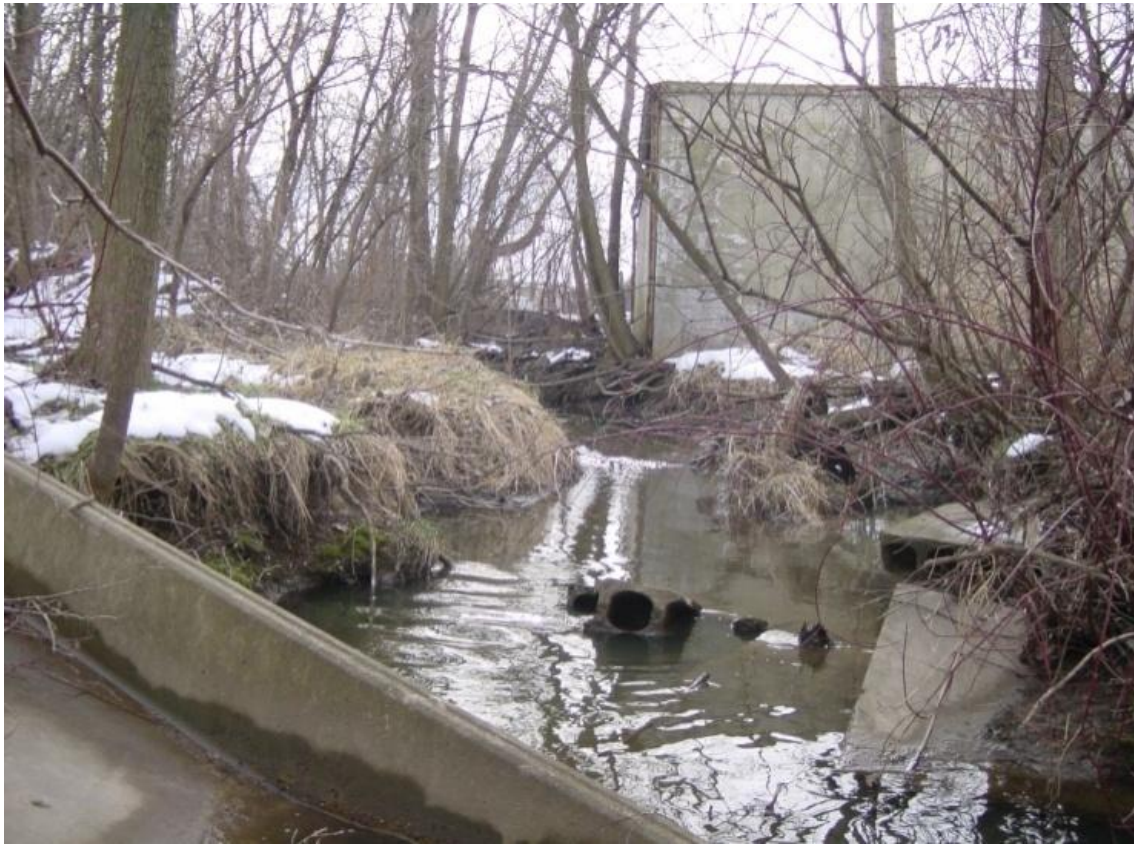
Blockages and debris in channel

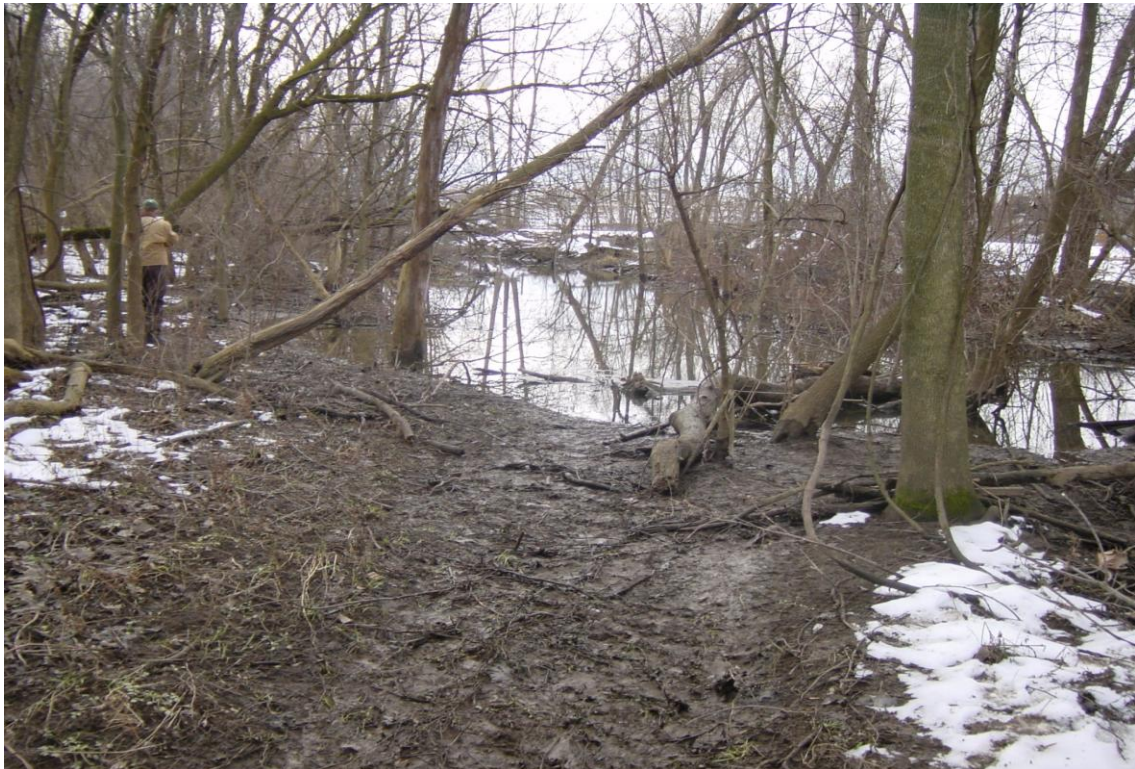
Upstream of building – unstable pattern and profile

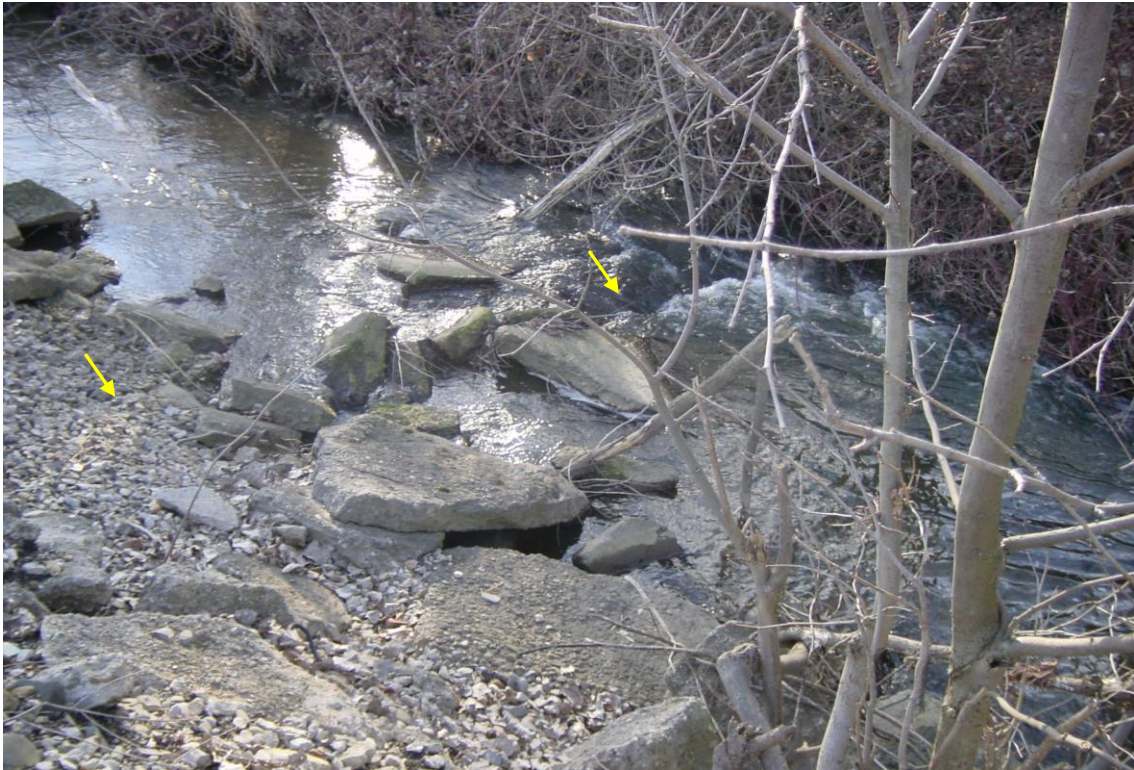
Failed stabilization efforts; excessive grade

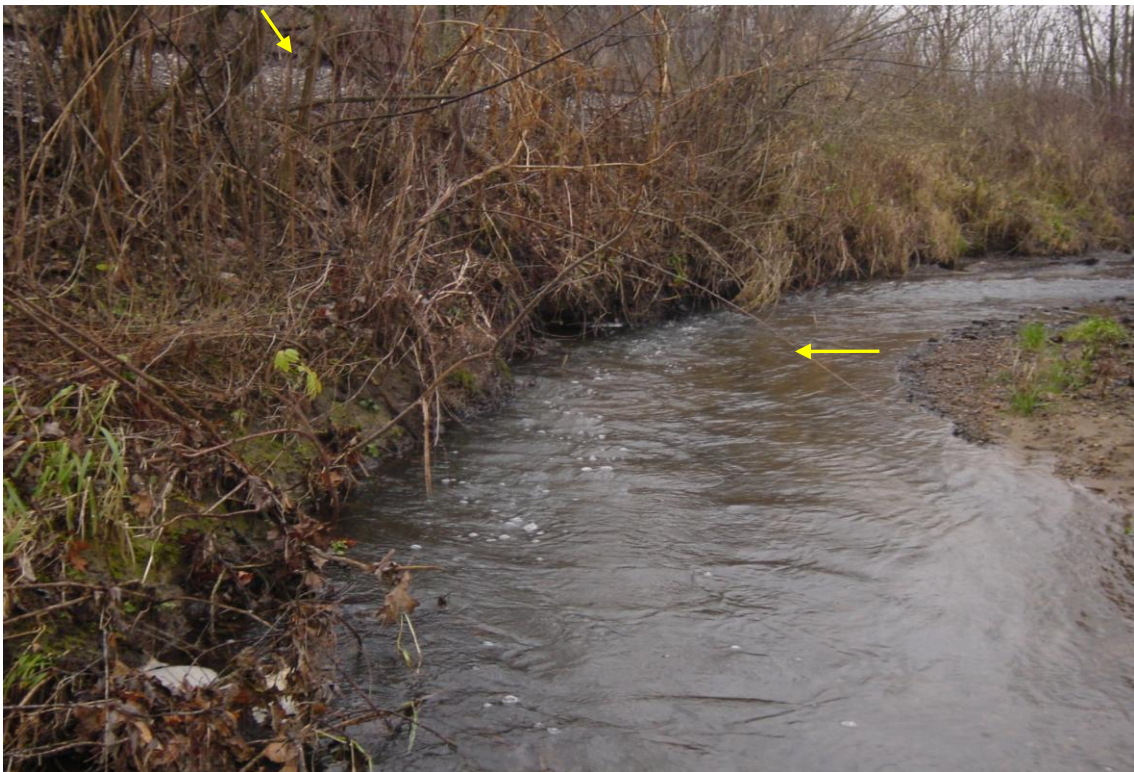
Sediment bar forcing flow to adjacent bank with railroad tracks

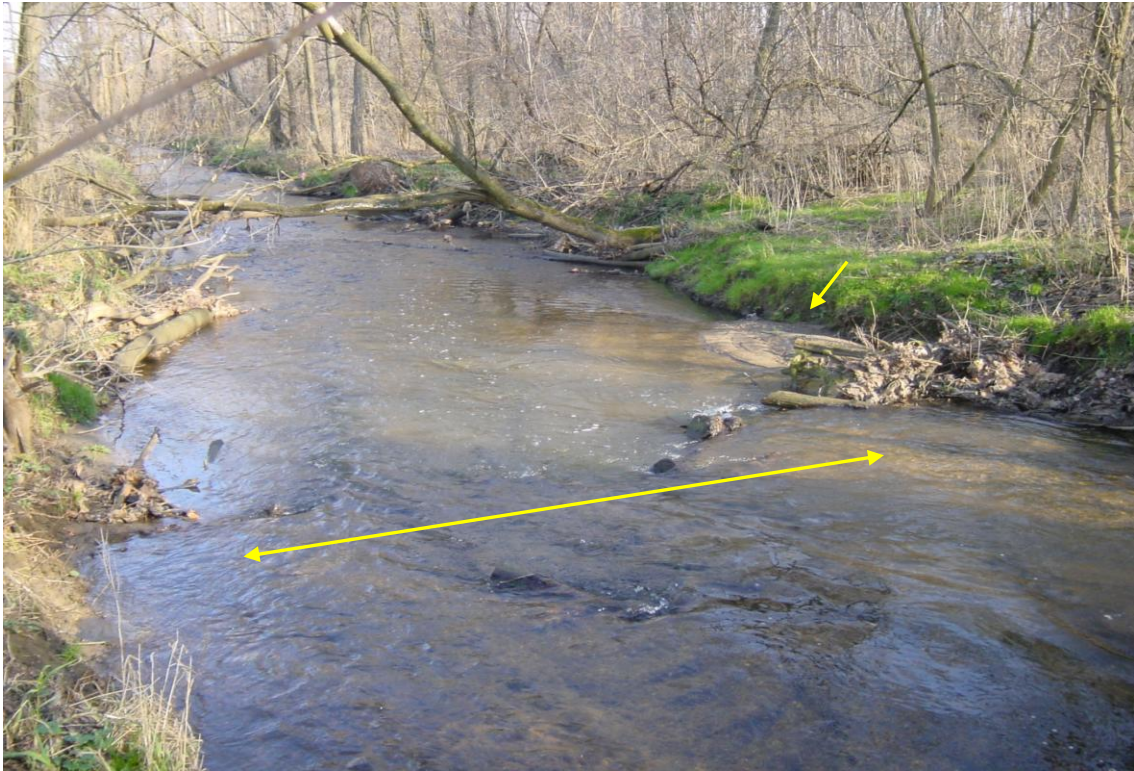
Sediment bar; overdensified channel resulting in undercutting and fallen trees

1	4 - Canadian National Railroad to Twin Culverts	Erosion; sedimentation; fallen trees	Over-widened channel; unstable banks	Create stable cross section and width-to-depth ratio; floodplain access	Install 1 vane and 12 cross vanes; remove 3 sediment bars. Install riprap bank protection.	\$54,450	Contractor, engineer	6-9 months
2	5 - Twin Culverts	Sedimentation; bank erosion; point bars; over-widening	Failed twin culverts	Create stable cross section and width-to-depth ratio; floodplain access	Remove 2 failed culverts and abandoned railroad tracks; approximately 120' of channel realignment; create floodplain bench; install 3 vanes and 3 cross vanes; install rock riprap bank protection. Remove 50' sediment bar and construct plunge pool.	\$27,250	Contractor, engineer	6-9 months
3	6 - Stewart Drive to Market Street	Sedimentation; braided channel; points bars; over-widened channel; fallen trees	Tight radius; high sinuosity; unstable pattern	Create stable pattern and profile	Realign 480' of channel and install 5 riffles for grade control.	\$21,240	Contractor, engineer	12-18 months

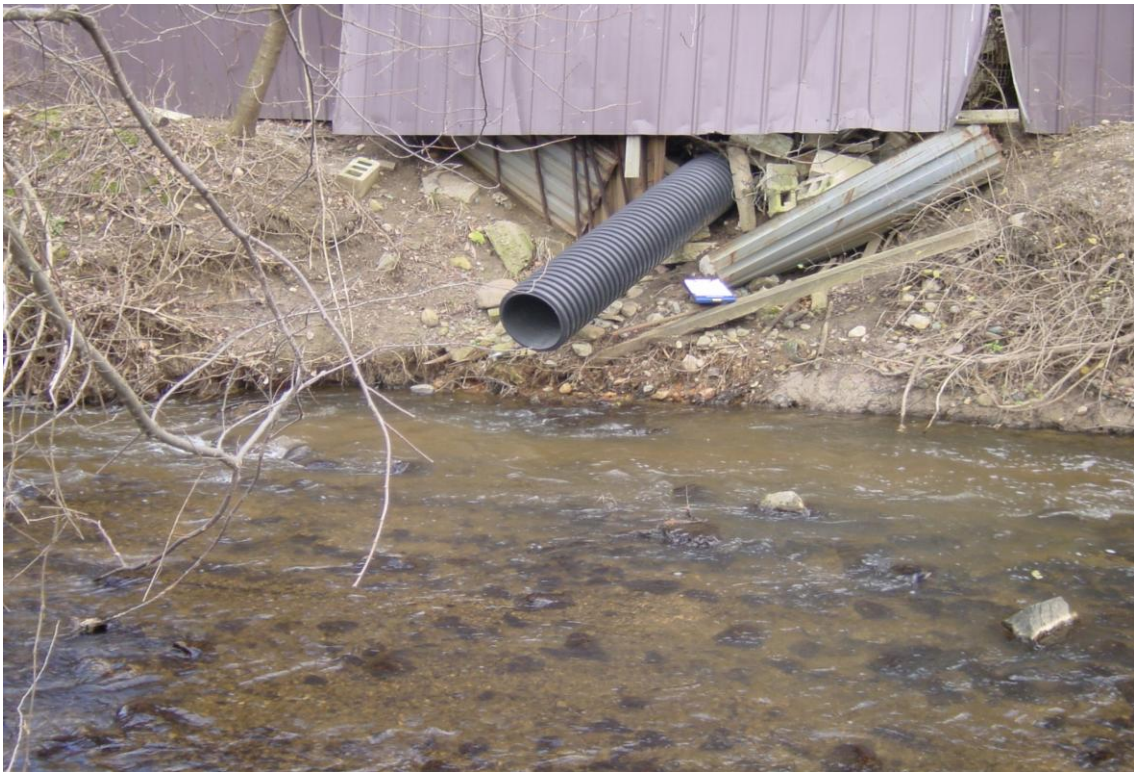
Bank erosion and debris downstream of railroad tracks

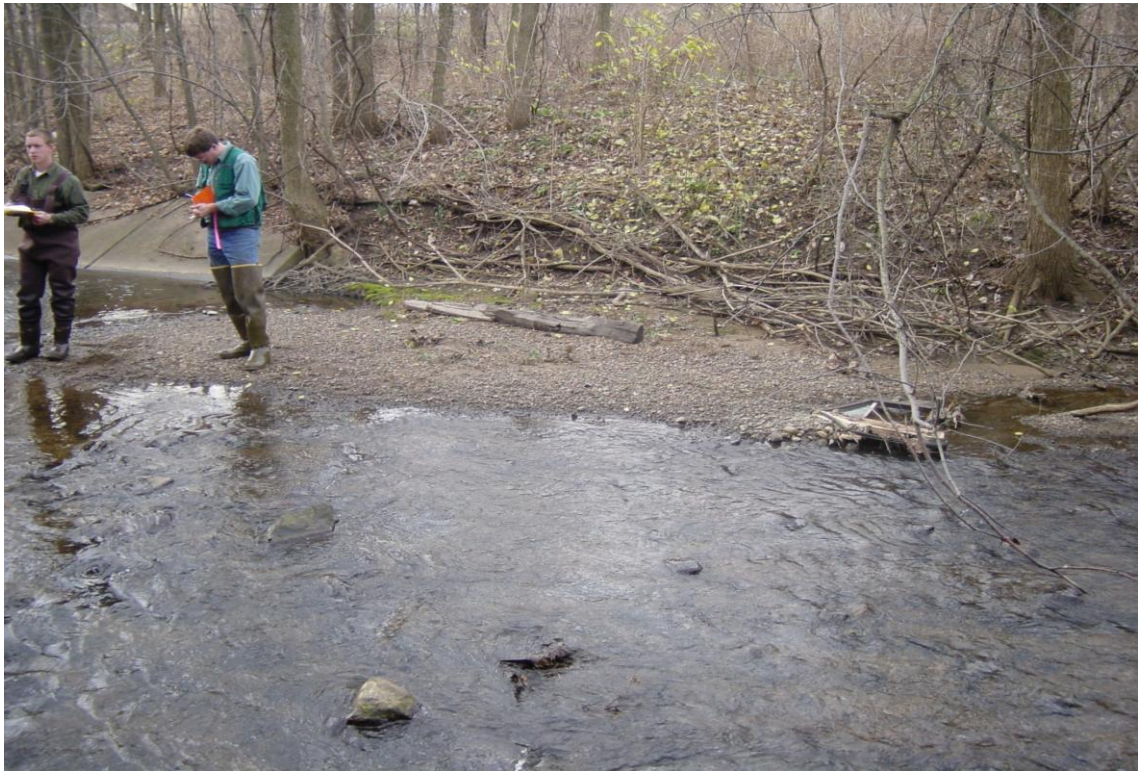
Sediment bar

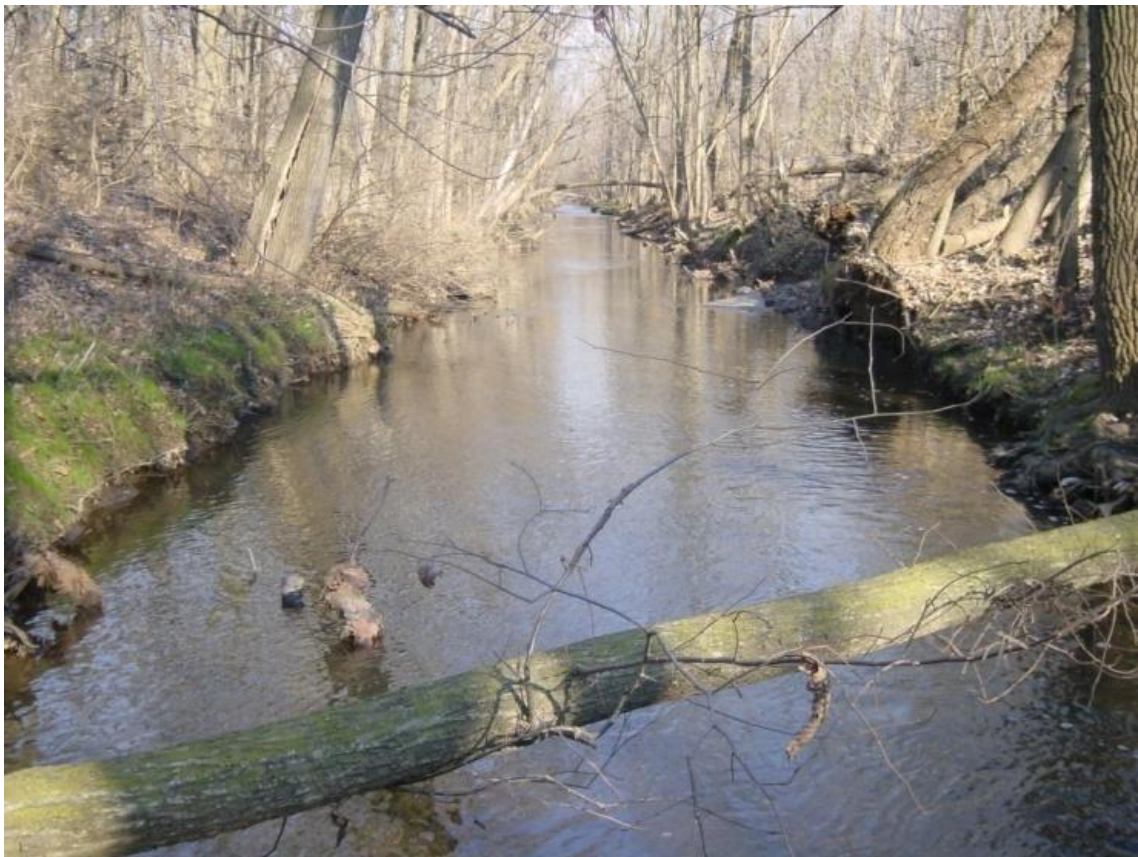
Over-widened channel; fallen trees

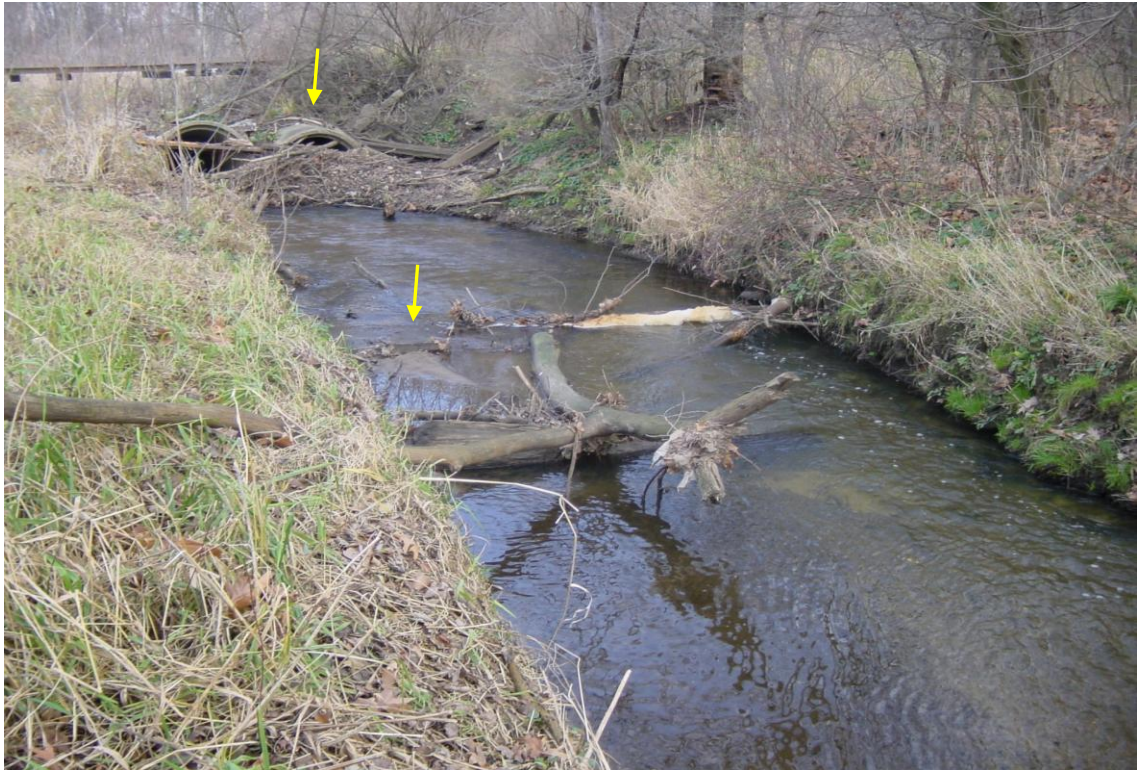
**Area 5 – Twin Culverts** – This area is located immediately upstream and downstream of BR I-94 and extends for a distance of approximately 750 feet. Twin culverts within this area have completely failed and the Davis has eroded around them for a distance of approximately 200 feet into the western bank. These culverts pose both a safety risk and have resulted in severe erosion and bank instability to the point that the abandoned railroad bridge is slowly collapsing into the Davis. The KCDC staff indicates that railroad ties regularly fall into the watercourse and are washed downstream on an annual basis causing the need for their removal through maintenance work. Overall, the Davis in this area is extremely unstable and continues to supply large volumes of sediment to downstream areas exacerbating already unstable conditions. Estimated bank erosion rates within this area are approximately 0.5 foot per year.

Blockages upstream end of twin culverts; sedimentation

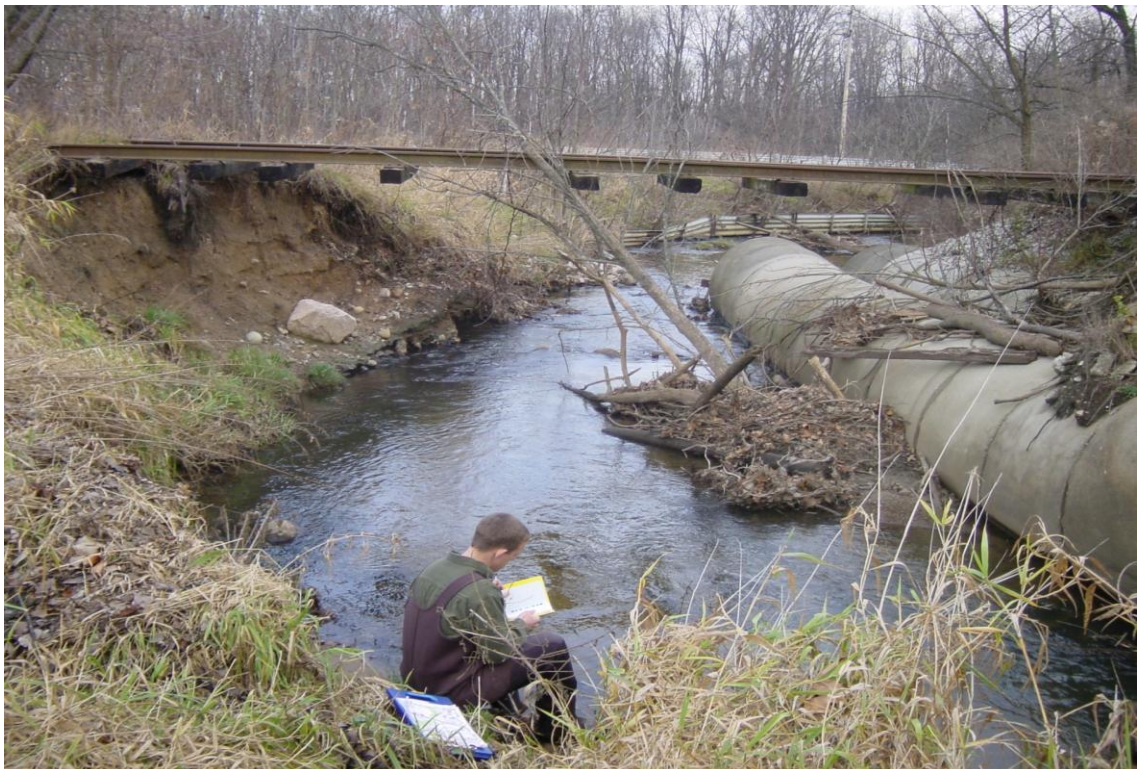
Excessive bank erosion; fallen trees; sedimentation

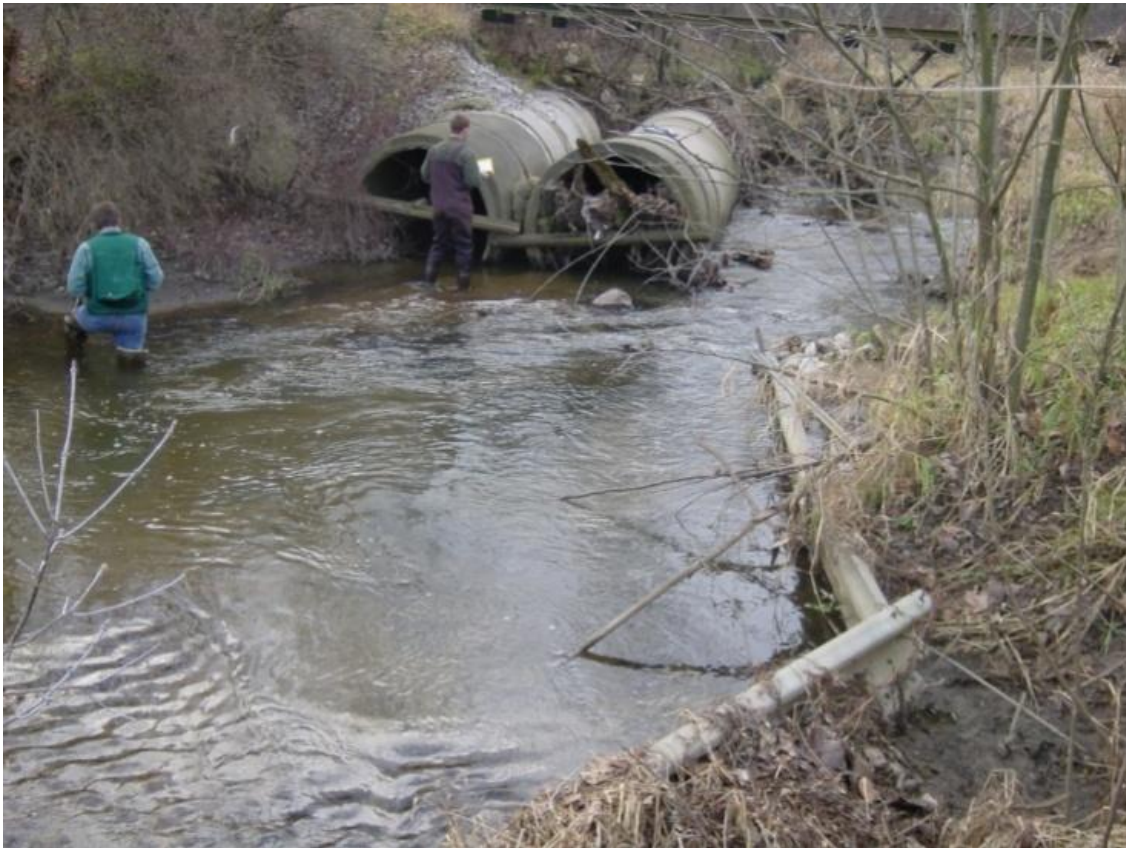
Almost all of the road culverts and drainage ways in the watershed are appropriately sized and, for the most part, functioning as intended. Field survey indicates that only 2 culverts (Area 5 – Twin Culverts) are in a state of total failure and one culvert (Area 1 – Deadwood Road) as requiring modification to better facilitate flow and improve hydraulic efficiency.

Failed culverts; bank erosion; blockages; sedimentation

Removal of failed culverts and/or culvert modification and alteration is recommended within two of the seven areas.

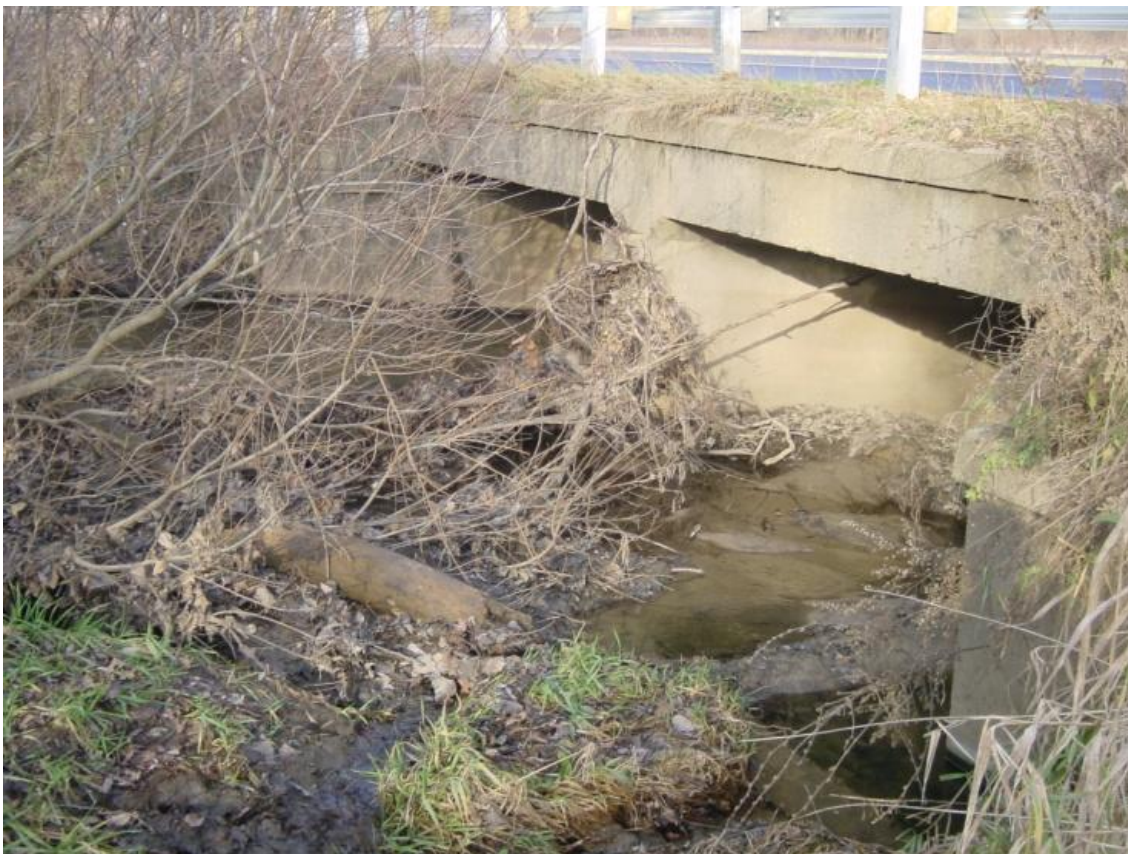
Sedimentation upstream of failed twin culverts

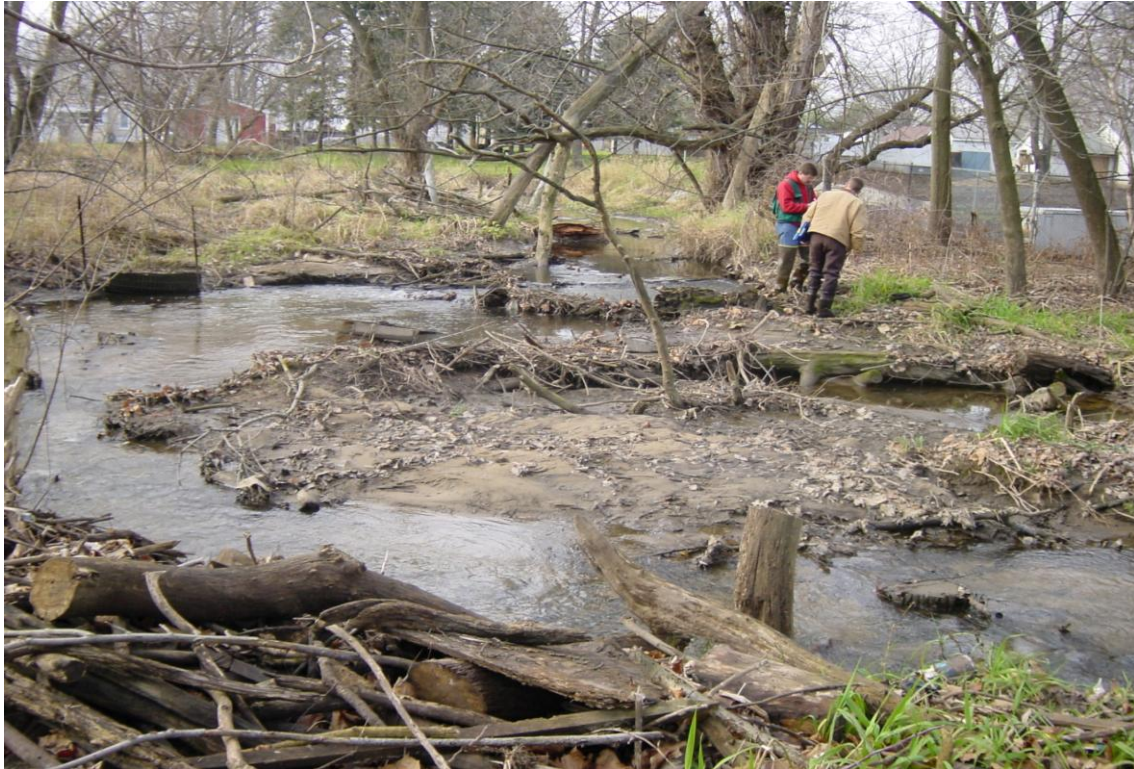
Unstable pattern; excessive sediment load

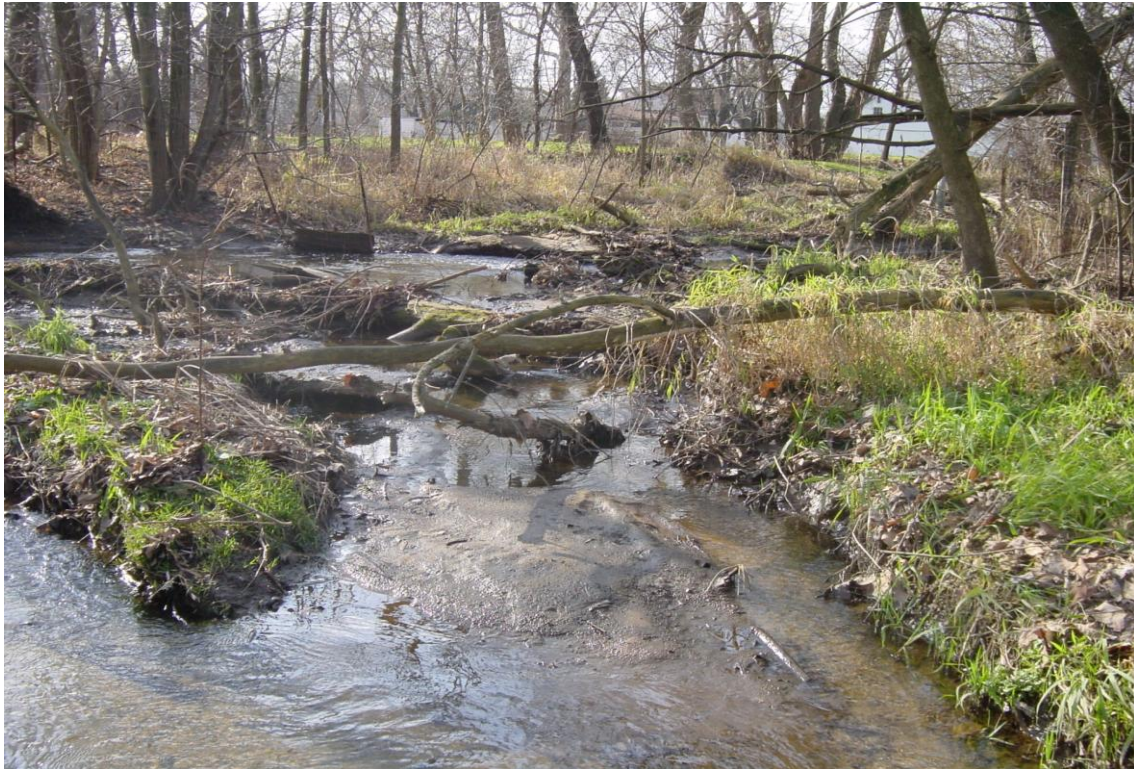
Braided channel; sedimentation; fallen trees; unstable pattern

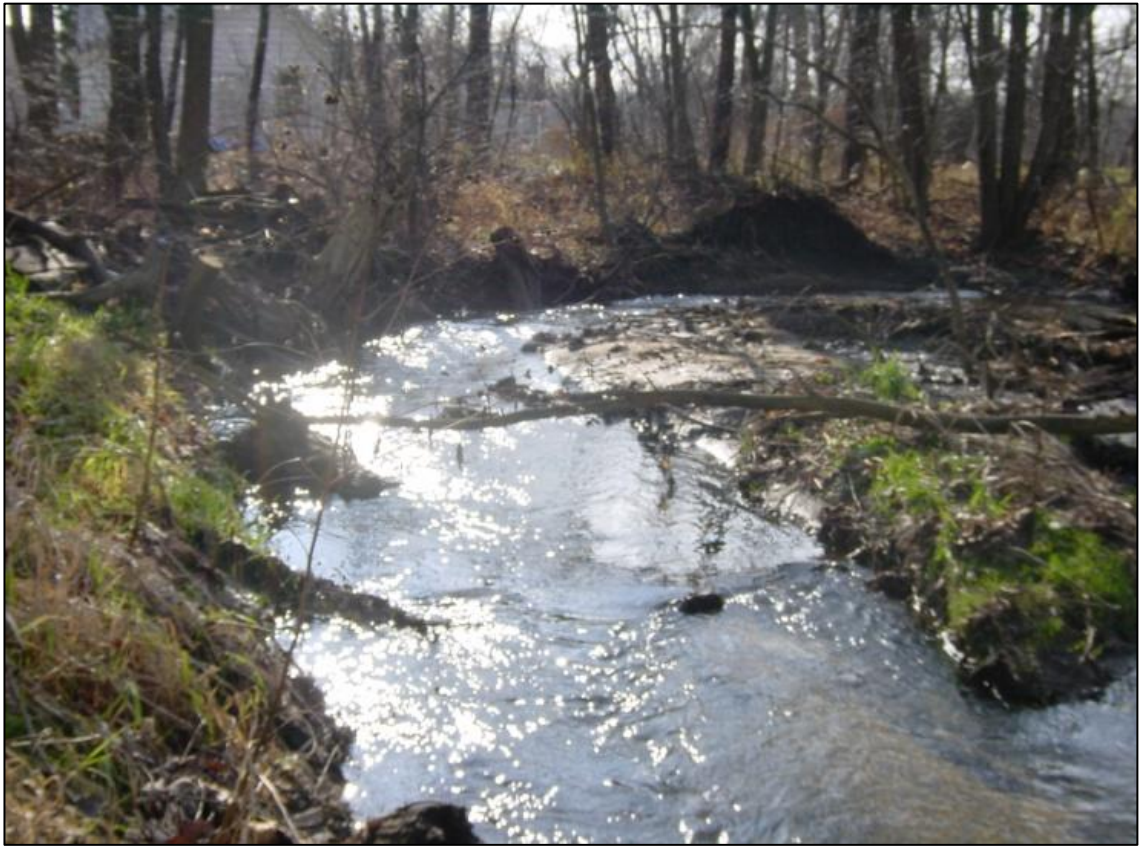
Sedimentation; fallen trees; unstable pattern

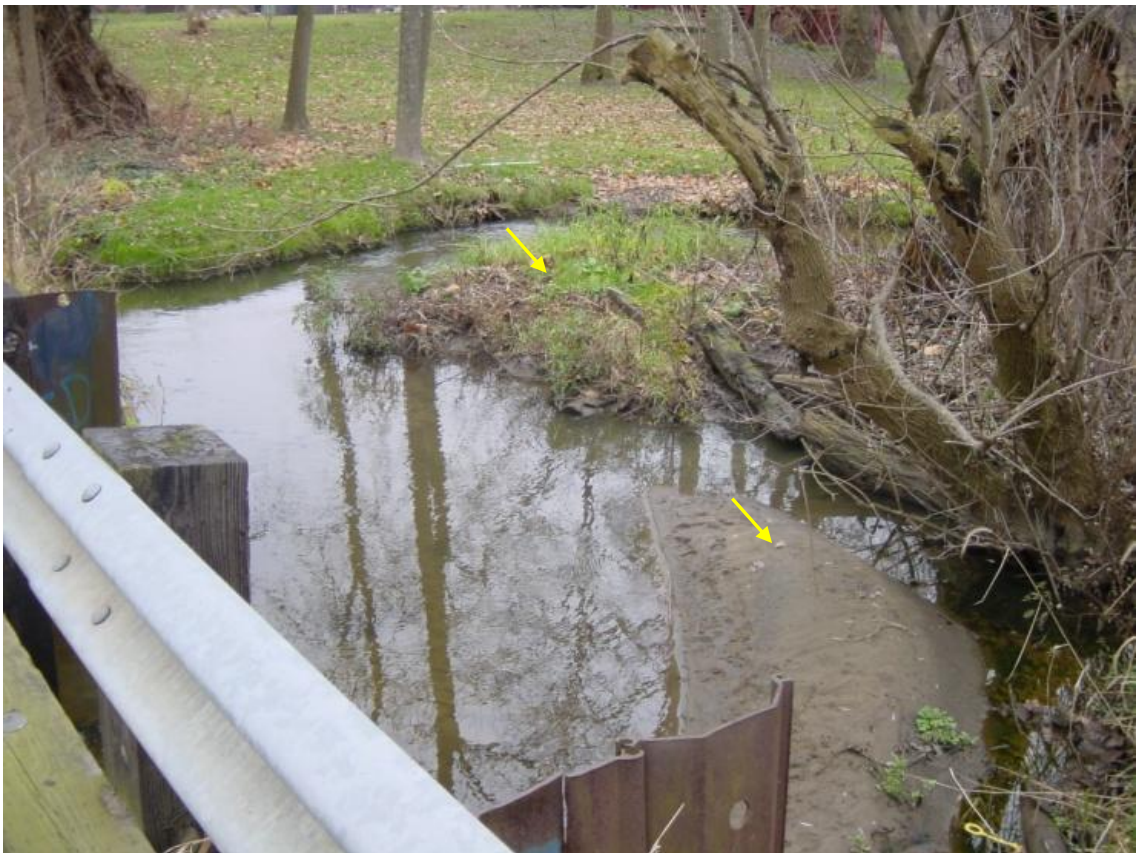
Sediment bars

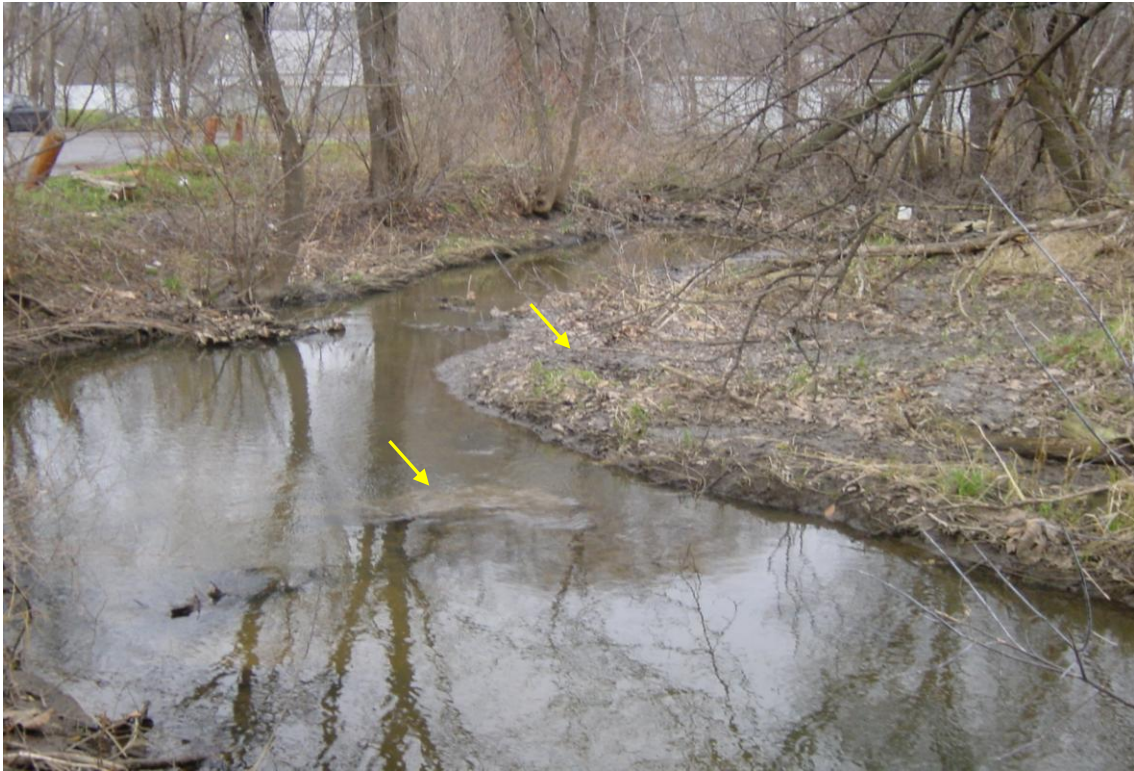
Sedimentation; point bars

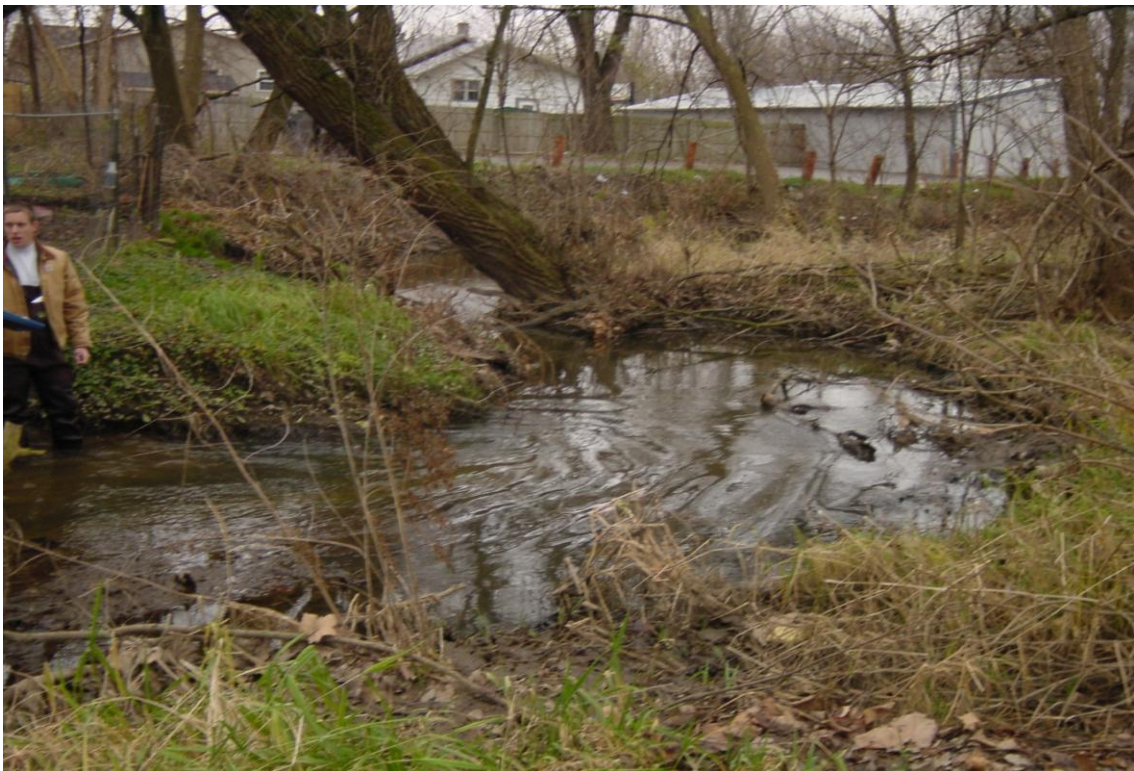
Tight meander pattern
