# **Engineering Report For:**

## **Davis Creek Phosphorus Reduction Study**

**Prepared for:**  
**Kalamazoo County Drain Commissioner**  
**Kalamazoo, Michigan**

**September 16, 2011**  
**Project No. G090661TS**

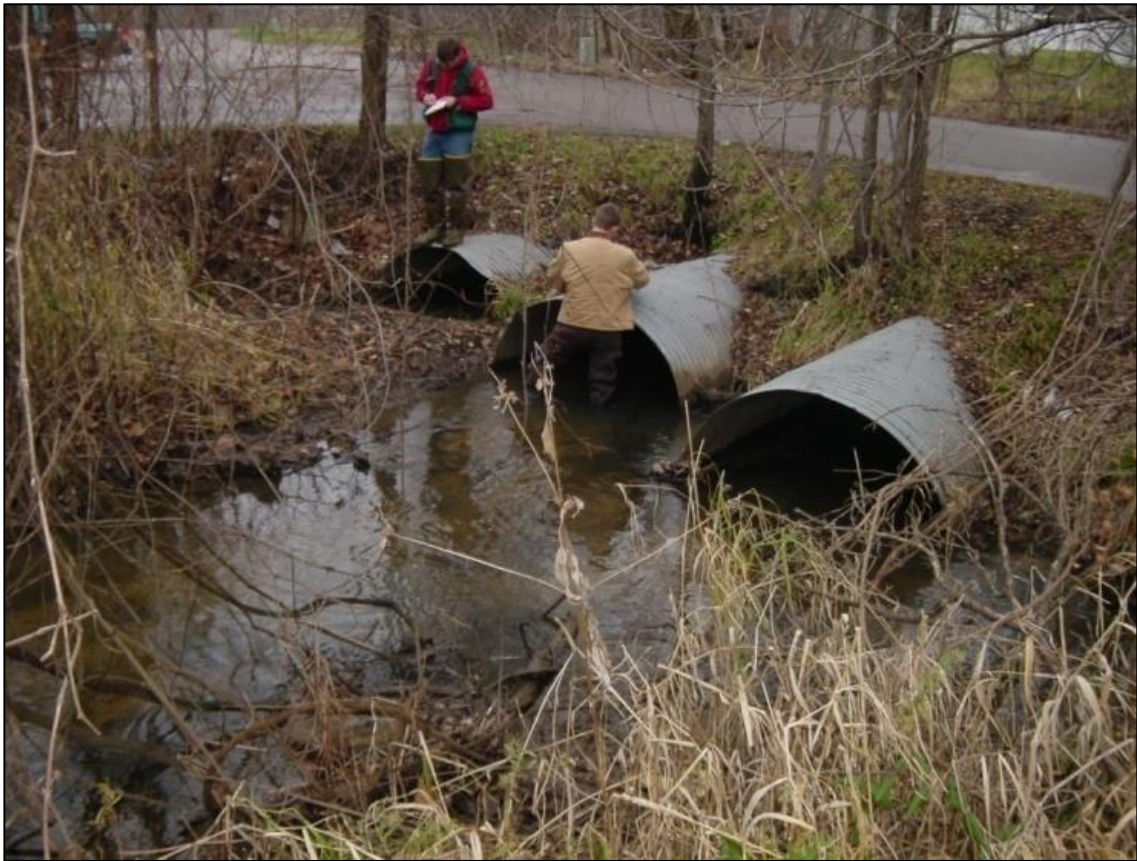
Plugged culvert

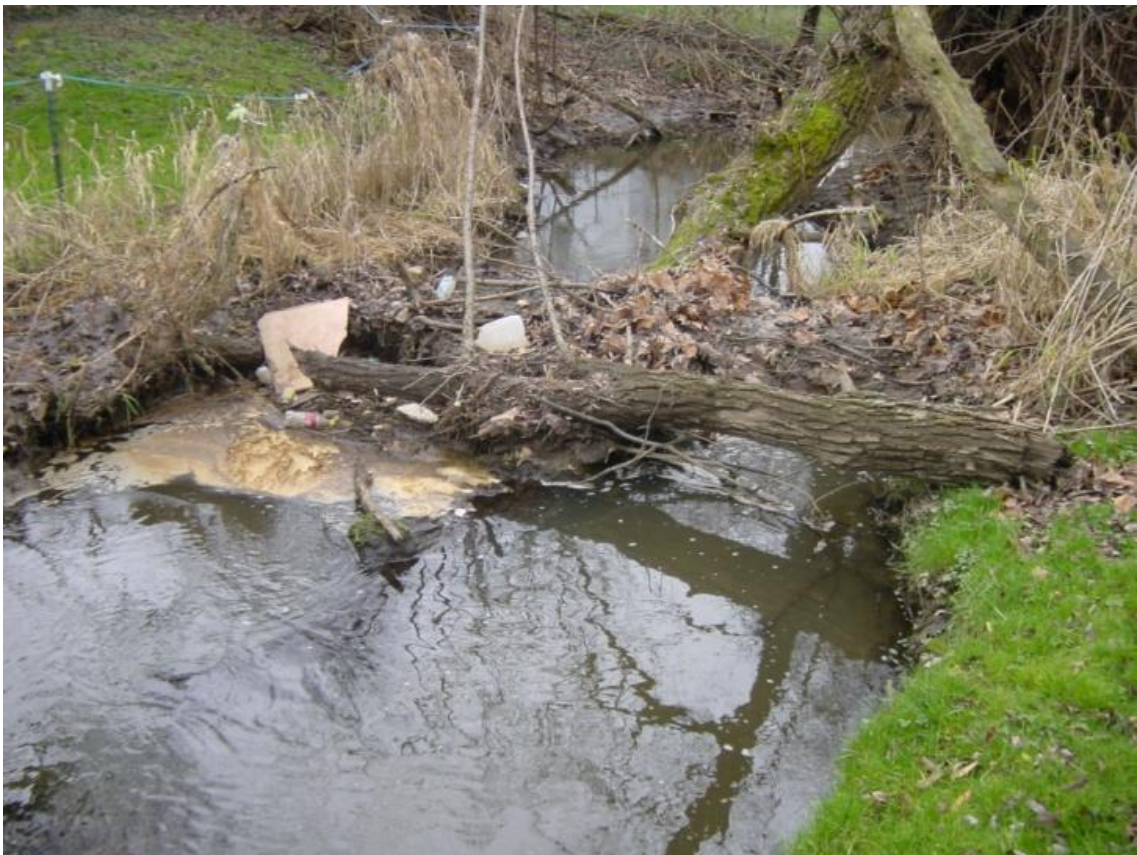
Debris; fallen trees
